# ANALYSIS OF THE REASONS FOR DEFECTS DURING FORMATION OF PROTECTIVE-DECORATIVE COATINGS ON WOODEN SURFACES

14th INTERNATIONAL SCIENTIFIC CONFERENCE **WOODEMA**

Dimitar Angelski, Pavlin Vitchev

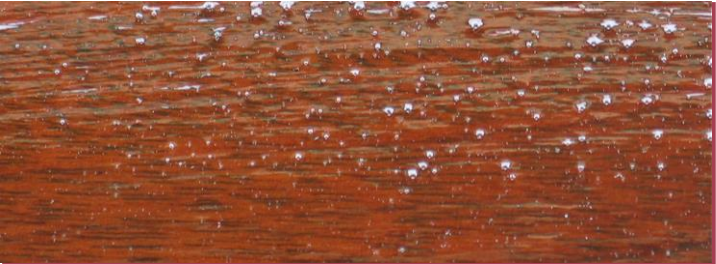
Bubbles	Thick applied lacquer layer; foamed lacquer; airflow and / or direct sunlight; hardener overdose; high temperature in the room.	Applying thin coatings; before applying the varnish, heat the wooden surfaces by 10-15 °C higher than the room temperature.

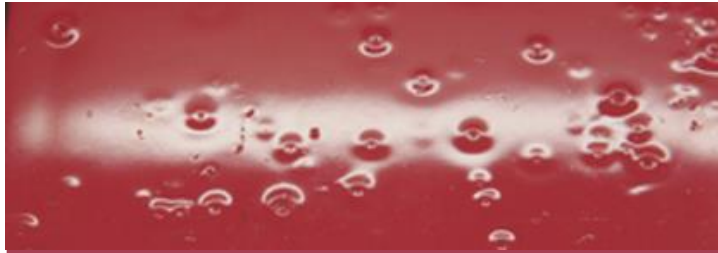
Craters

Chemical incompatibility of some substances contained in wood (resins, essential oils) with the varnish systems used.

Pre-priming with appropriately selected insulating primers.

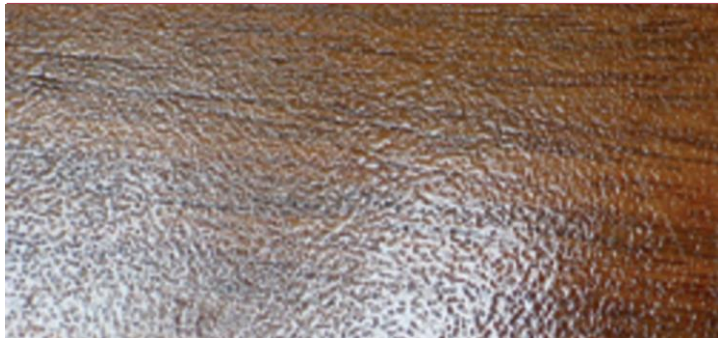
Orange peel

Poor varnish spillage; high viscosity; incorrectly dosed composition; unsuitable technological regimes; airflow; high temperature drying.

Observing the technological regime, as the defect is very difficult to remove. It does not disappear completely even after sanding.

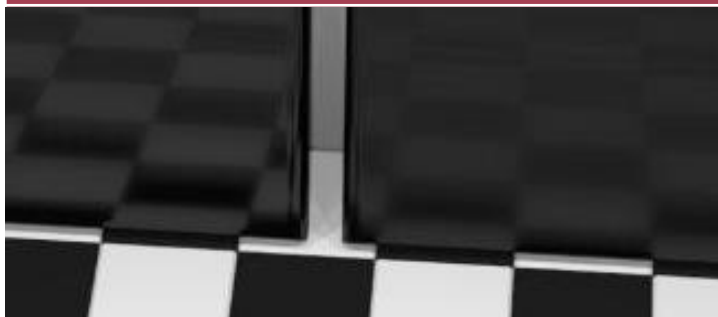
Loss of gloss (less gloss)

Poor quality of varnishes; inaccurate dosing of components; sanding the film before it has reached technological hardness; unsuitable polishing regime.

Sanding and re-polishing; sanding and applying a new layer of high quality gloss varnish.
